Phase II

Assessment of Conditions

Phase II: Assessment of Conditions

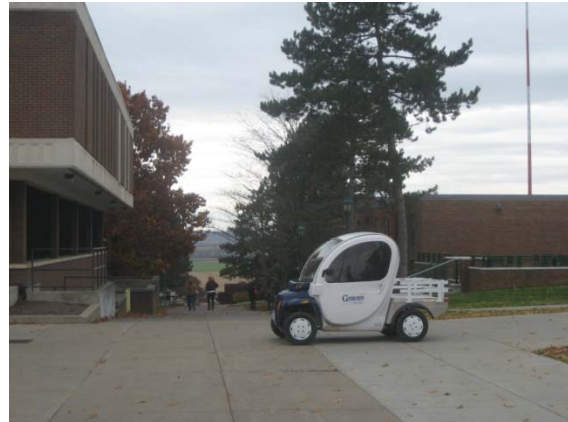
Electric/GEM car observed near the College Green

parked on various sidewalks and plazas throughout campus. The College should consider establishing guidelines for their use, so they do not become a substitute for walking or cause parking problems on sidewalks and plazas.

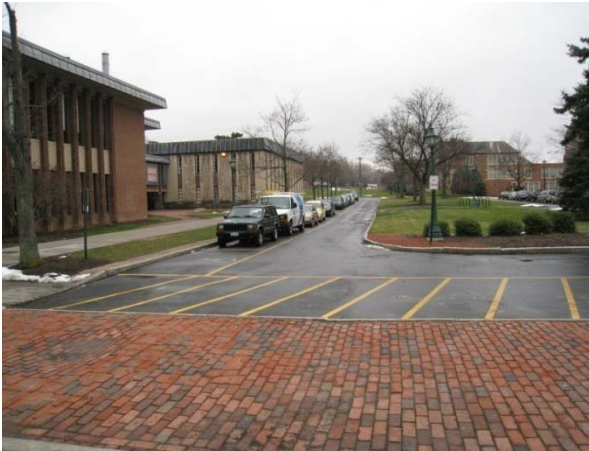
The primary walkways on the upper quad are scored concrete, both at College Circle and the College Green. The curbing and pavement at College Circle are showing signs of settlement and normal wear and tear, and could benefit from rehabilitation. If College Circle is rebuilt, consideration should be given to eliminating the striped pavement areas and replacing with either sidewalk or pavers.

Brick unit pavers, asphalt paving, and granite curb at College Circle are showing wear and tear.

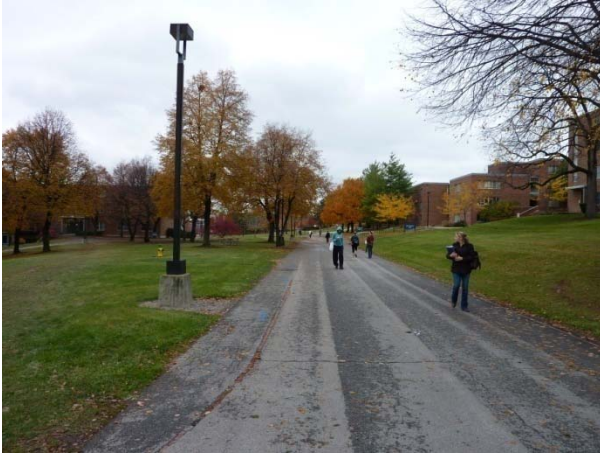
Drive to the end of MacVittie Union plaza consists of an approximately 16 foot wide former road bed with a brick soldier course and paved shoulder, creating an environment that can be confusing to vehicles and pedestrians alike.

View north toward University Drive. The appearance of this walkway appears as if intended for vehicles.

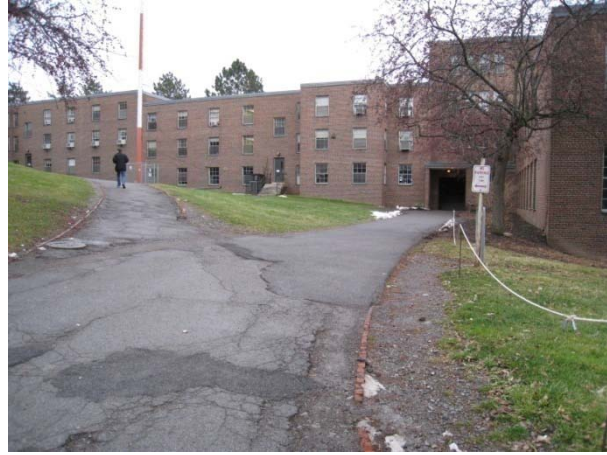
Asphalt walkways behind Milne Library are in poor condition. Providing ADA-accessible walkways from North Village to the upper quad in this area will be considered.

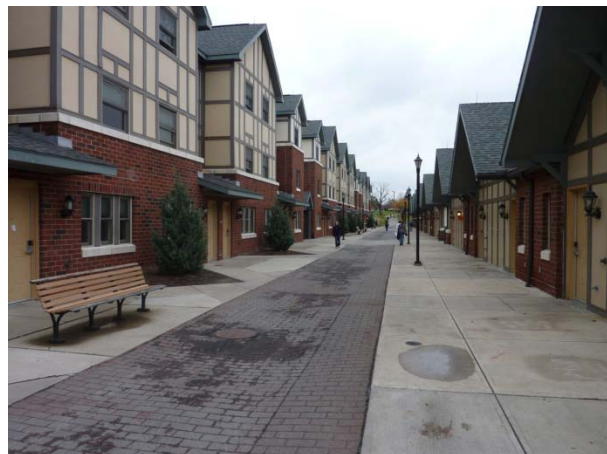
At Saratoga Terrace, the pavement treatment consists of scored concrete and stamped asphalt. The stamped asphalt has performed poorly and has lost its color and is showing signs of settlement and cracking. At South Village, most of the sidewalks are scored concrete in good condition. At most of the residence halls and at Red Jacket dining hall, there are brick paver plazas that were installed with mortar joints that have since failed. Nassau Hall has a large stamped concrete plaza. While all the pavements appear to be in fair to good condition, the ambiguity of wide asphalt drives intruding into primarily pedestrian spaces creates confusion and possible pedestrian/vehicular conflict.

The stamped asphalt at Saratoga Terrace has lost its color and settled in many places, creating low spots and puddles when it rains.

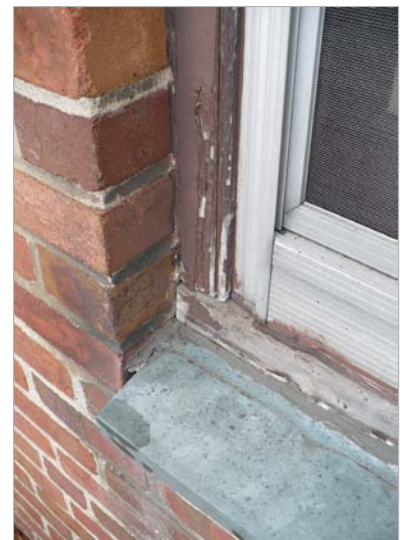
Windows are in poor condition and should be replaced with energy-efficient, double-glazed units.

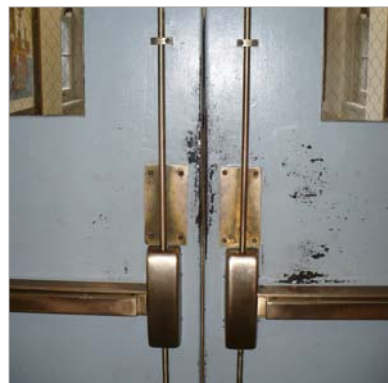
Interior doors are in fair condition.

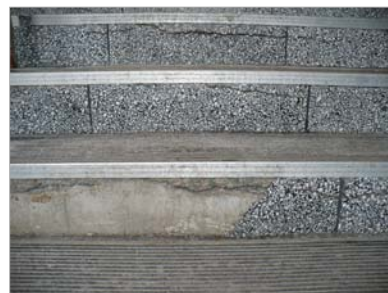
Worn stair treads should be replaced.

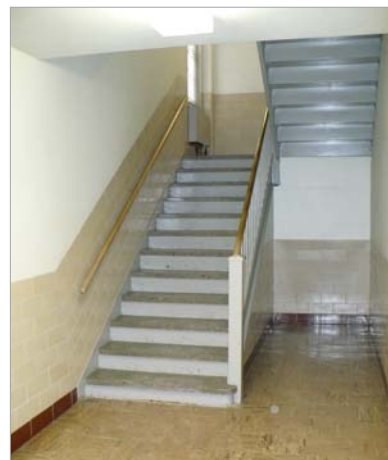
Handrails are not accessible.

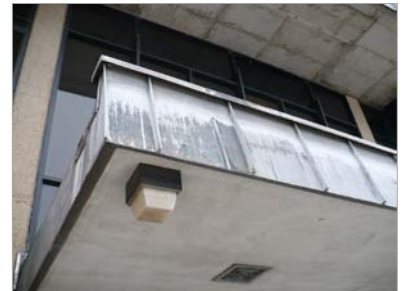
The canopy at the main entrance is in fair condition.

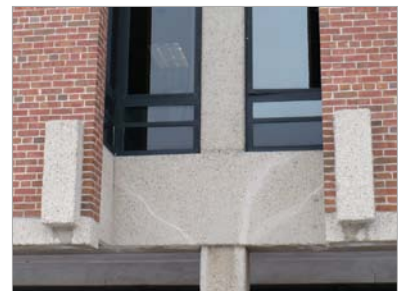
Cracks in the exterior walls indicate building settlement.

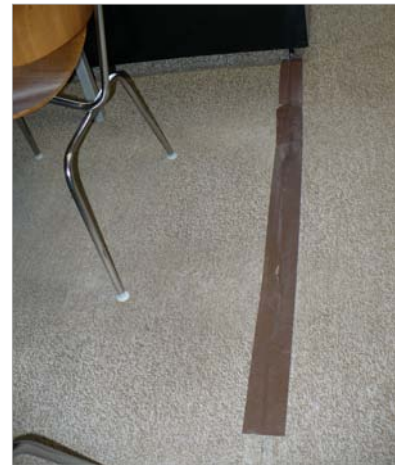
Carpet is in poor condition.

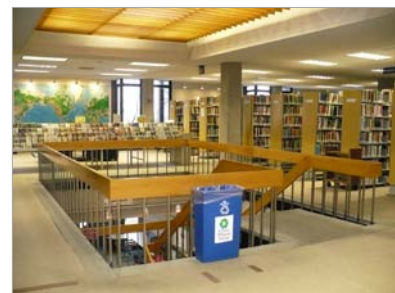
Handrails are not accessible and do not meet requirements of the New York State Building Code.

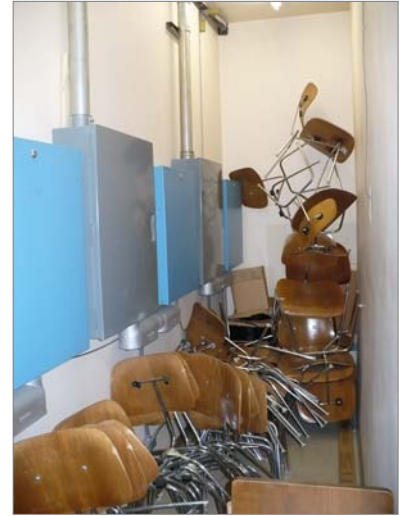
Minimum clearances are required at electrical panels.

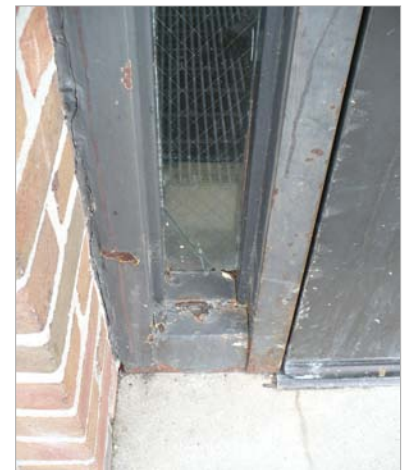
Several exterior doors are in poor condition.

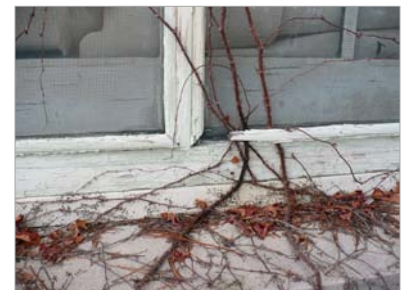
Windows are in poor condition and should be replaced with energy efficient units.

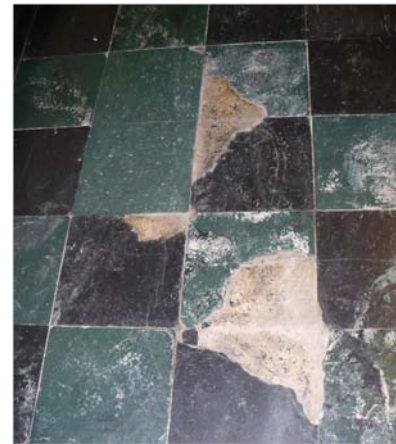
Flooring throughout the building is in fair to poor condition.

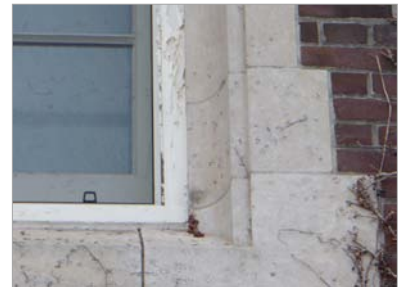
Some windows need to be repainted.

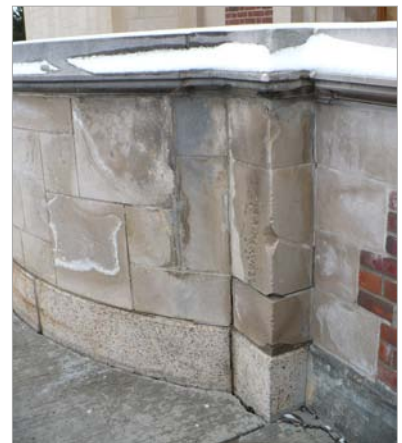
Retaining walls around the perimeter of the building are in poor condition.
