Phase II

Assessment of Conditions

Phase II: Assessment of Conditions

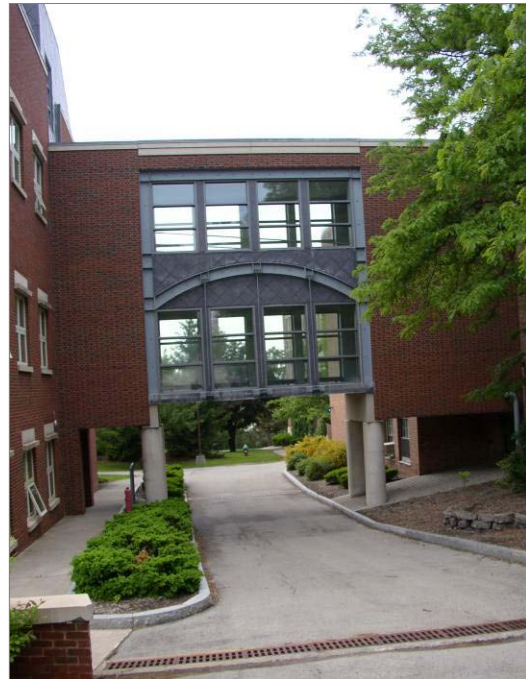
The service drive between Fraser and South Hall coincides with the pedestrian path, resulting in confusing wayfinding.

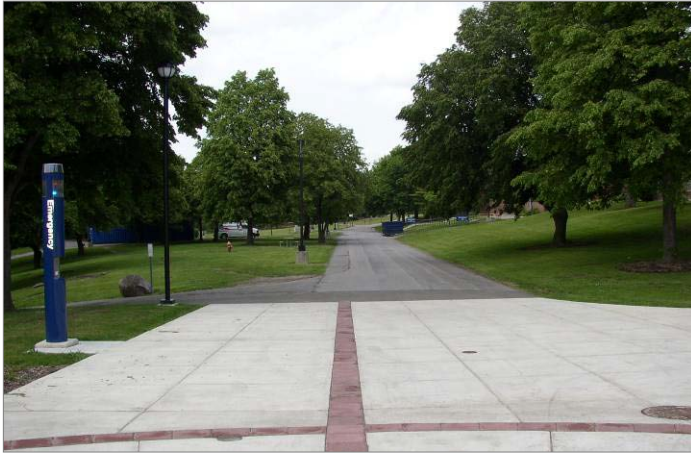
There is an opportunity to extend the axis from MacVittie Union plaza to the north to strengthen the connection to the North Village.

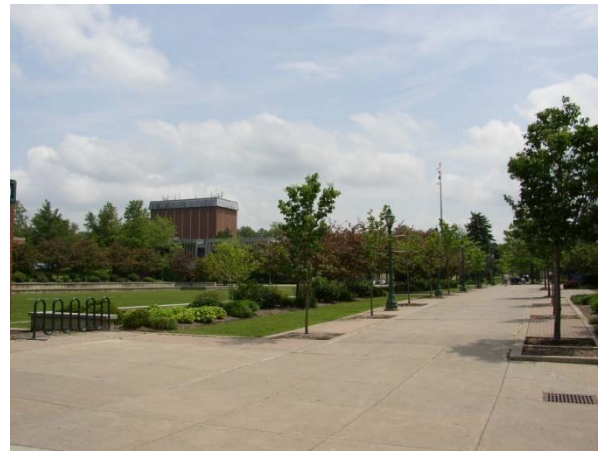
College Green sidewalks are scored concrete with concrete unit paver bands.

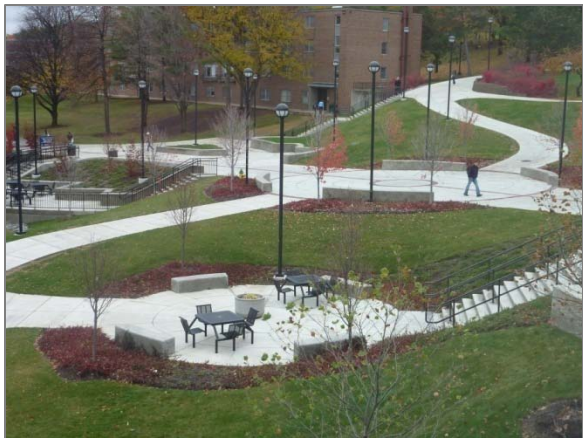
Sloped areas of campus pose challenges to building construction.

As indicated above, the moderately-sloped areas of the campus pose challenges to building construction. The Cashaqua shale bedrock underlying the soil overburden is often encountered in a tilted position, creating particular foundation problems due to the “slippage lines” parallel to the rock surface. Moderate and steep slope areas that pose construction or access problems are indicated on the topographic plan.

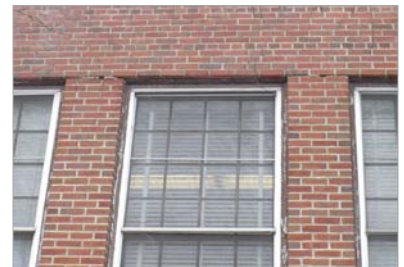
Mortar at the head of the windows is beginning to deteriorate.

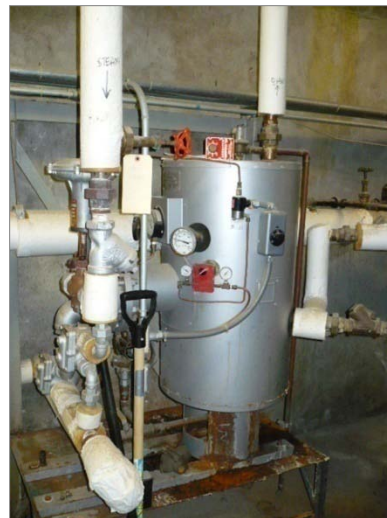
Steam water heater

During the winter months domestic hot water is provided by a semi-instantaneous steam-water stainless steel storage tank. It has a copper tube bundle used to maintain water temperature. Based on external observation, the unit is in good condition. A definitive inspection is recommended. This requires disassembly of the heater and removal of the tube bundle so the interior of the storage vessel and exterior of the tube bundle can be inspected.

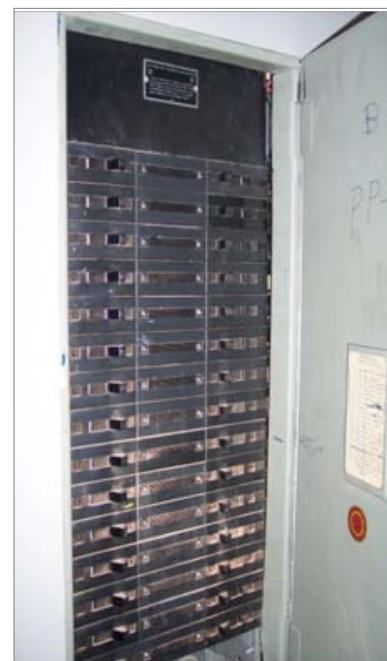
Branch Circuit Panel

Electrical distribution in Fraser Hall is provided by a 400 AMP 120/208V 3ph. 4w General Electric Spectra Series Distribution Panel. Power is distributed throughout the facility through 120/208V, 3ph 4w branch circuit panels. The distribution panel is older than 20 years and is in fair condition. Some branch circuit panels are older than 20 years and are in fair condition, the majority are much older and in poor condition.

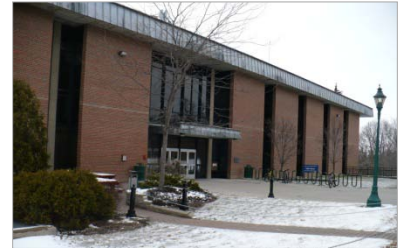
- The metal fascia at the entrance canopy and around the perimeter of the building is in fair condition.
- Exterior walls and soffits appear to have been patched repeatedly. This may indicate previous building settlement. Other indications include large cracks and loss of mortar in the brick paving around the building. It should be closely monitored for problems that may arise in the future.
- The single-glazed windows are in good condition, but are not energy-efficient and should be replaced with double-glazed units.
- Caulking around the windows is beginning to crack and is in fair condition.

The canopy at the main entrance is in fair condition.

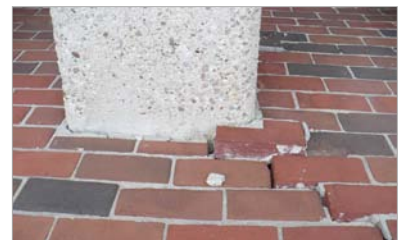
Brick paving around the perimeter should be replaced.

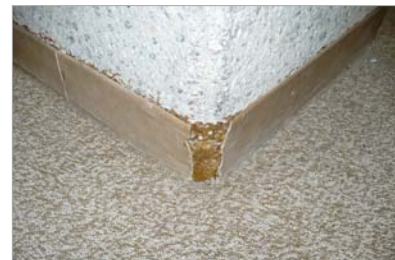
- Carpet in the stack areas is torn, stained, buckled, and in poor condition. There is tape in some places to prevent it from being a tripping hazard.
- Floor tile in the stairs is in fair to poor condition and may contain asbestos.
- Vinyl base throughout the building is peeling, cracking, and in poor condition.
- Ceramic tile in the toilet rooms is cracking and metal ceiling tiles are in fair condition.
- Stains on second floor ceilings and around the skylight in the northern stair indicate past water infiltration.
- Interior doors are generally in fair condition, with some peeling veneer.
- Finishes in the existing elevator are worn and in poor condition. The library staff has requested a larger elevator to accommodate the distribution of library materials.

Vinyl base in poor condition should be replaced.

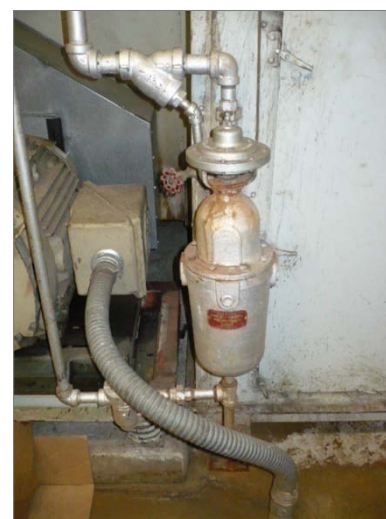
Typical direct injection steam humidifier

Both air-handling units have steam humidifiers that inject low-pressure steam directly into the plenum to add humidity to the air during winter months. This form of humidification may also inject harmful boiler treatment chemicals (return line amines) into the air that may be harmful to the occupants of the building. The College should consider an alternate type of humidification, such as self-contained electric/gas fired humidifiers or a central unfired steam generator that uses steam from the Heating Plant to boil water and create steam for humidification. No testing of the humidification system control operation was done as part of this review.

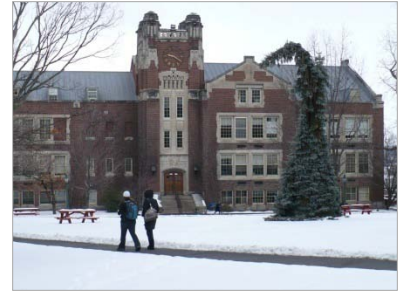
- The masonry wall adjacent to the stair at the southeast corner of the building is deteriorating and in fair condition.
- Mortar at the northeast corner of the building is beginning to deteriorate. It should be raked and repointed.
- Many of the exterior doors are rusting and in poor condition.
- Handrail posts at the main entrance stair have started to rust near the ground.
- Single-glazed windows are in poor condition and are missing screens in many locations. They should be replaced with energy-efficient, double-glazed units.
- Some of the concrete walkways around the building are heaving, resulting in a tripping hazard, and should be replaced.

Several exterior doors are in poor condition.

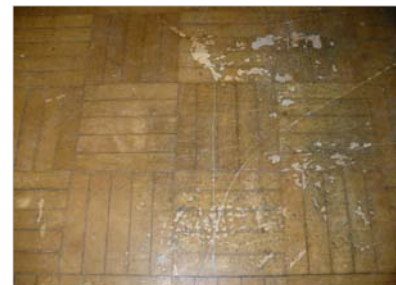
The parquet wood floor in the auditorium should be refinished.

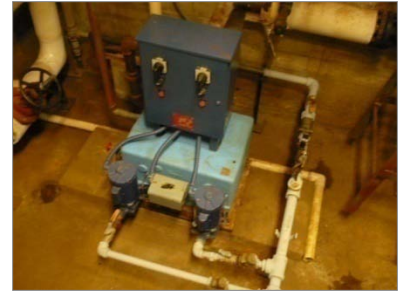
Main condensate pump/tank set

Steam condensate pumps appear to have been replaced, but are over twenty years old. The low-pressure steam is controlled by a master valve that is connected to the Heating Plant control system. The steam valve appears to be less than fifteen years old, but the valve control panels are much older. Steam traps, condensate pumps, and system distribution piping do not appear to be original to the building, but are more than twenty years old. Any visible pipe insulation was recently replaced as part of an asbestos abatement project.

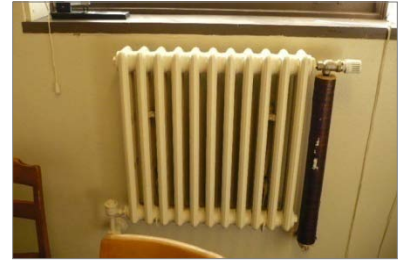
Typical office radiation

Perimeter and entryway heating is achieved by means of cast-iron radiation using low-pressure steam. Classrooms are served by a unit ventilator system that consists of a fan unit, steam coil, and outside air provisions.

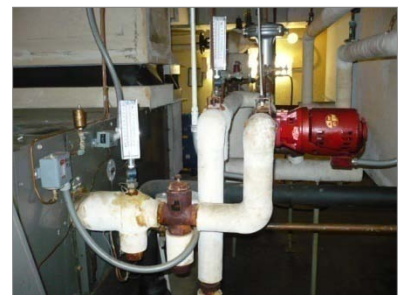
Lower-level HVAC system

There is no central air-conditioning system in the building, although one small central system is installed in the lower level on the north end of the building for faculty offices in that area. Other offices use window air-conditioning units.

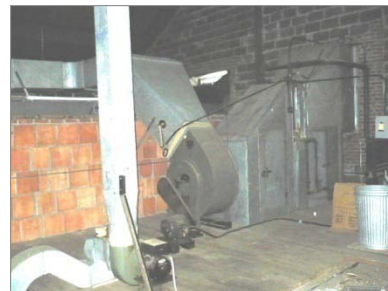
Auditorium supply and exhaust fans

The auditorium on the second floor has a dedicated supply and exhaust system that appears to be original to the building. It uses fans to exhaust the air, but has damaged steam coils and cannot be used in the winter.

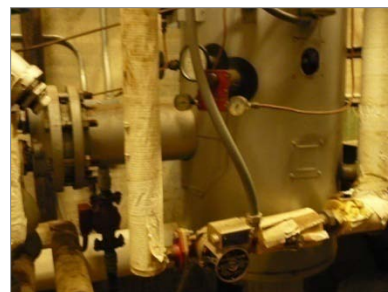
Steam water heater

During the winter months domestic hot water is provided by a semi-instantaneous steam-water stainless steel storage tank. It has a copper tube bundle used to maintain water temperature. There is an intermittent water hammer associated with the operation of the water heater, which has been attributed to the condensate piping. The unit is in good and serviceable condition. A definitive inspection is recommended. This requires disassembly of the heater and removal of the tube bundle so the interior of the storage vessel and exterior of the tube bundle can be inspected.

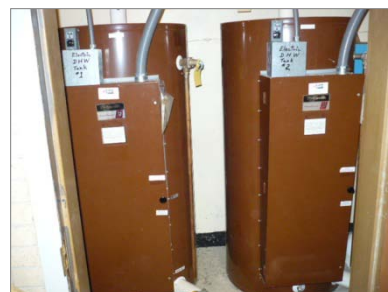
Electric water heaters

In the summer months when the Heating Plant is shut down, the steam to water storage tank is manually turned off and electric storage-type water heaters provide domestic hot water to the building. The electric water heaters are in good condition.

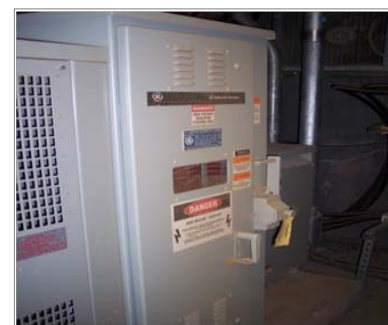
Main switch gear

Electrical distribution in Sturges Hall is provided by a 1200 AMP 120/208V 3ph. 4w General Electric Spectra Series Main Distribution Panel. Power is distributed throughout the facility through 120/208V, 3ph 4w Westinghouse branch circuit panels. The Main distribution equipment is older than 20 years and in fair condition. The Westinghouse branch circuit panels are older than 40 years and are in poor condition. In some locations newer style panels have been installed and are in fair condition. The existing electrical service will be adequate for upgrading mechanical systems as long as the same type domestic hot water system is used for heating. If central air conditioning were to be considered for the building then the service size would need to be evaluated to verify if there is enough power available.

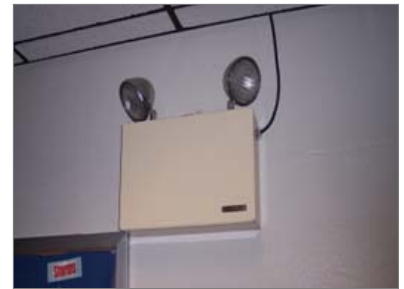
Emergency light

Classroom lighting is surface mounted fluorescent fixtures in poor condition. They are not energy efficient, primarily due to age. If the lighting were replaced with similar type but energy efficient lamps and ballasts, an approximate payback would be ten years. More accurate payback calculations could be done based on specific fixture and lamp types. The corridors have 2' x 4' lay-in parabolic light fixtures which are in fair condition. The emergency lighting in the corridors is provided by Emergilite wall packs with battery backup. The wall packs are older than 10 years and in fair condition.

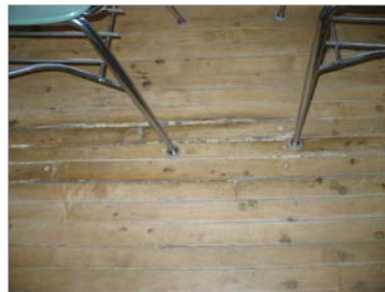
Wood flooring in the classrooms is in poor condition.

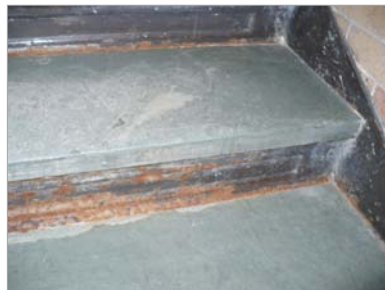
Metal stair risers are rusting.

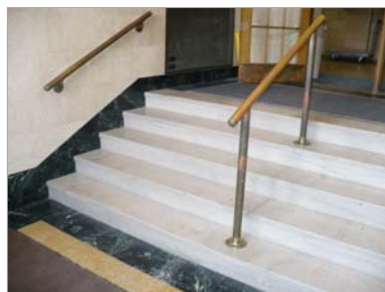
Handrails do not meet requirements of the accessibility guidelines.

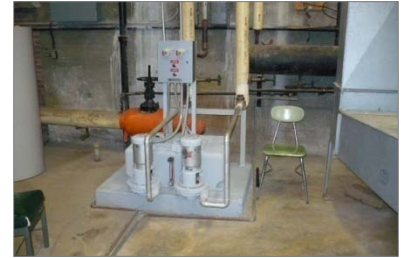
Main condensate pump/tank set

Steam condensate pumps appear to have been replaced, but are over twenty years old. The low-pressure steam is controlled by a master valve that is connected to the Heating Plant control system. The steam valve appears to be less than fifteen years old, but the valve control panels are much older. Steam traps, condensate pumps, and system distribution piping do not appear to be original to the building, but are more than twenty years old. Any visible pipe insulation was recently replaced as part of an asbestos abatement project.

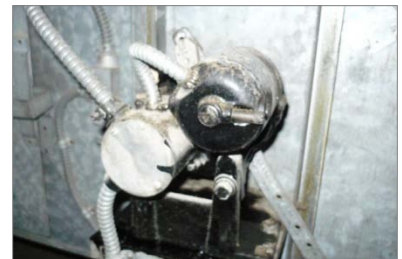
Original damper motor/actuator

Exhaust ducts in the attic space have single, flat sheet steel dampers to control the ventilation rate. Due to their simple design, the dampers do not seal tightly. The damper actuators are original to the building, but are not connected to the dampers and, therefore, are assumed to be inoperable. Testing of these devices was not possible at the time of inspection.

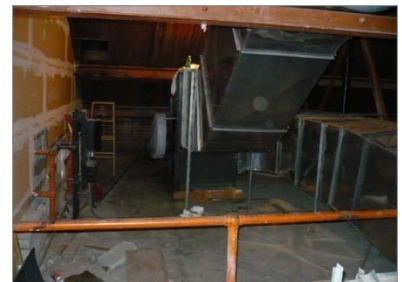
Center exhaust fan system

The separate exhaust system located in the center section of Welles Hall uses an electrically-powered fan to exhaust air. The system appears to have been added to the building after construction. This fan system is an additional system that does not connect to the gravity vent systems previously discussed.

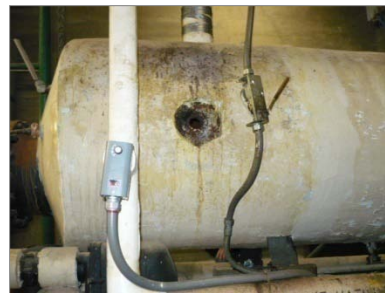
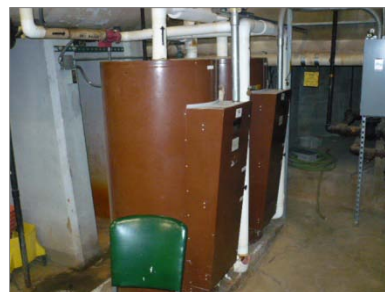
Abandoned steam hot water tank

A vertical storage tank with a steam bundle has been abandoned in place due to sidewall tank corrosion. Therefore, electric heaters are used year-round for domestic hot water. The electric heaters are in good condition. Insulation on the abandoned storage tank may contain asbestos.

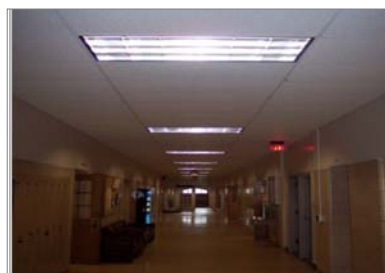
Recessed fluorescent lighting

The lighting in the classrooms is surface mounted fluorescent fixtures. The corridors include a mix of decorative incandescent and 2' x 4' lay-in parabolic light fixtures. The lighting overall is in good condition. The emergency lighting in the corridors is provided by Emergilite wall packs with battery backup. The wall packs are older than 10 years and in fair condition.

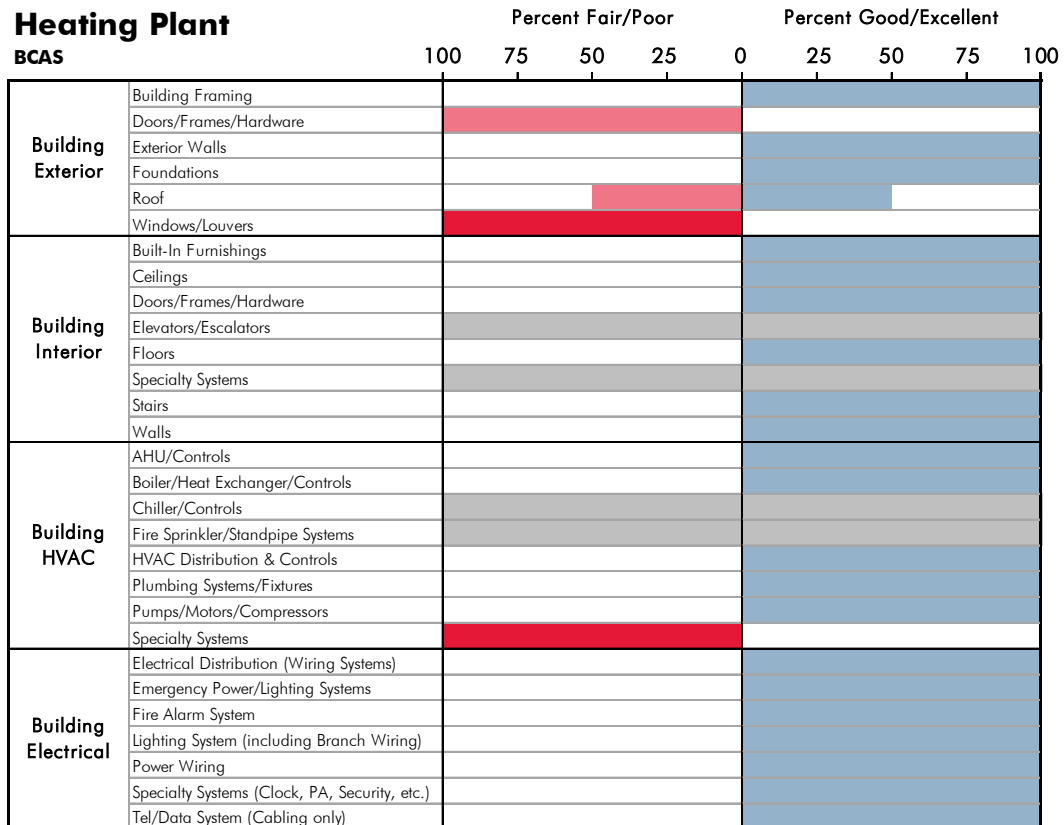
Centrally located, the Heating Plant serves many of the campus buildings. In addition to mechanical rooms, the building contains offices, lockers, and a break room for facilities personnel. All spaces in the building are well-organized and in good condition.

- Doors/Frames/Hardware: Exterior doors are rusting and in poor condition.
- Foundations: Hairline cracks were found in some of the concrete foundation walls.
- Windows/Louvers: Single-glazed windows appear to have been repainted in the last five years, but are not energy-efficient and should be replaced.

- Specialty Systems: Lockers in the building are beginning to rust.

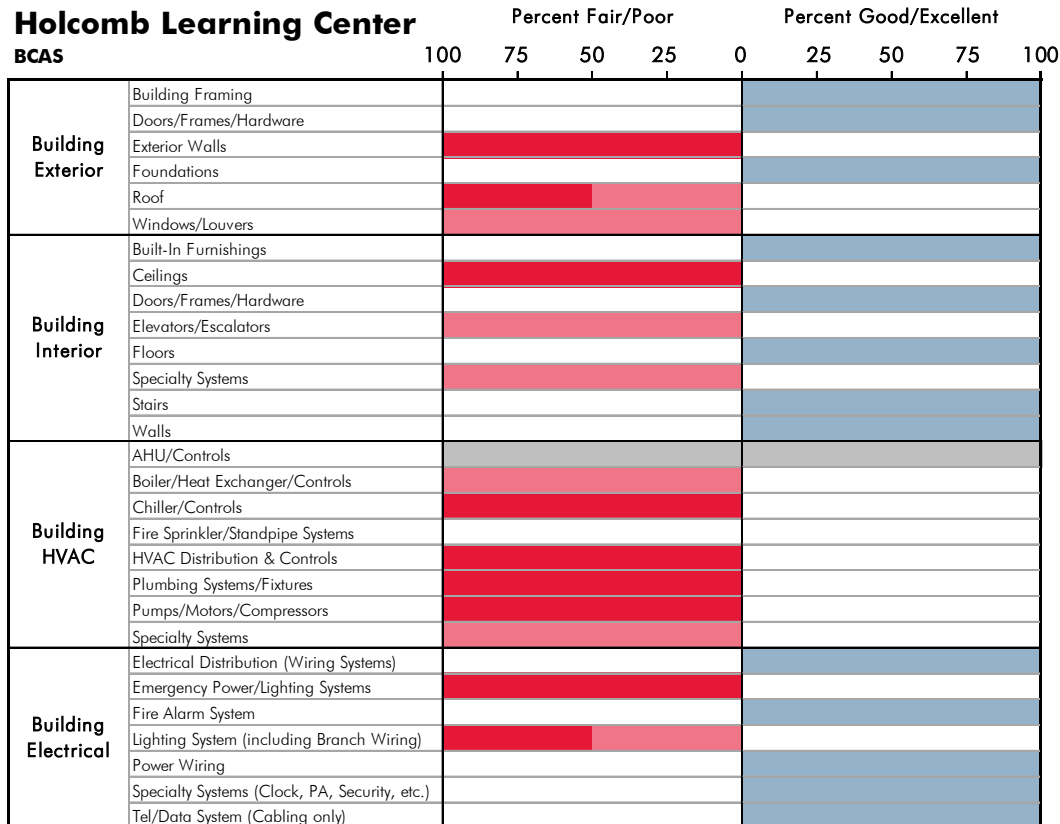
Originally constructed in 1969 as an elementary school, the Holcomb Learning Center is well-suited for the daycare and preschool programs that currently occupy a large portion of the building. The College also leases space to the Livingston County Council on Alcohol and Substance Abuse (LCCASA) and Alliance for Business Growth. The remainder of the building is vacant, with the exception of a few classrooms at the south end. The College plans to demolish the building in the next few years to provide space on campus for a new stadium.

- Exterior Walls: Masonry walls are in good condition, but minor cracks have developed at several locations. Exterior sealant is beginning to deteriorate.
- Windows/Louvers: Single-glazed windows are not energy-efficient and should be replaced with double-glazed units.

- Built-in Furnishings: Casework in the building is deteriorating and in fair condition.
- Ceilings: Concealed spline ceilings and some acoustic tile ceilings are in poor condition. The remaining ceilings are in fair condition.
- Doors/Frames/Hardware: Some interior doors are in fair condition.

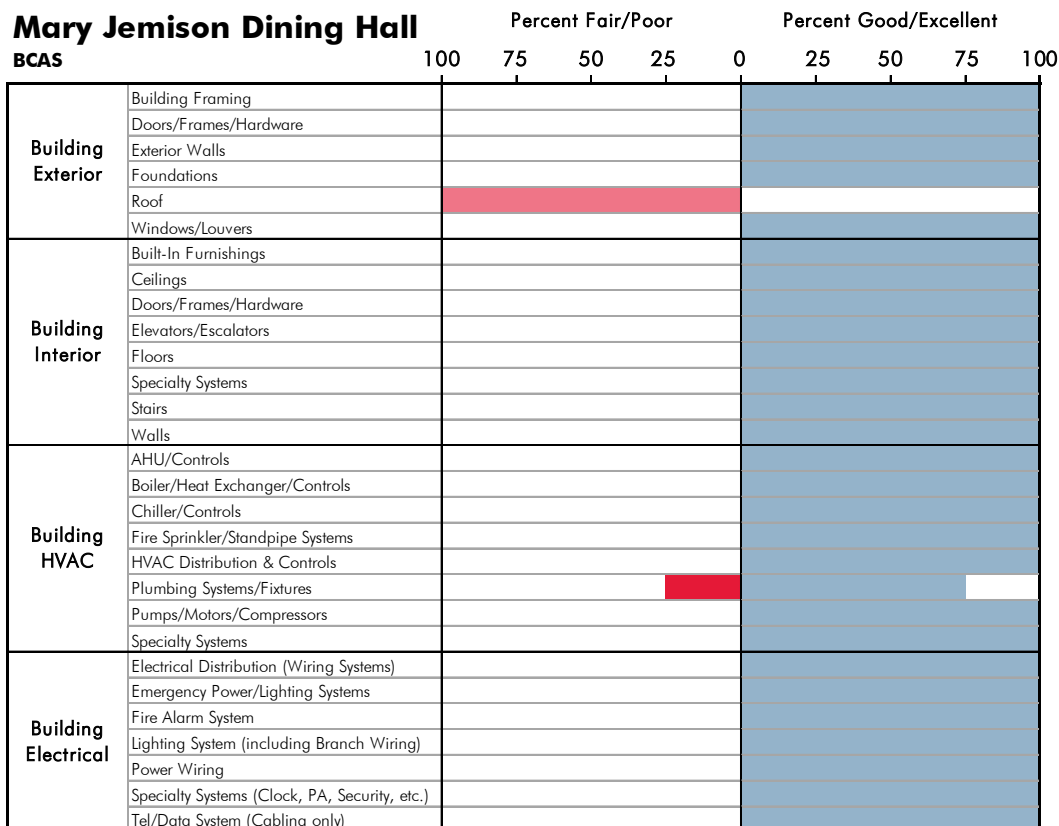
Mary Jemison Dining Hall

Mary Jemison Dining Hall, originally constructed in 1960, is located in the center of campus. It has dining and service on two floors, with a large commercial kitchen located on the first floor. It was recently renovated and is in good condition.

- Exterior Walls: Major cracks have developed in the masonry veneer on either side of the second floor entrance.

- Built-in Furnishings: Some casework on the first floor is beginning to delaminate.
- Floors: Some floor tile in the southwest stair is cracking and in poor condition.
- Stairs: The risers of the main stairs are beginning to rust.

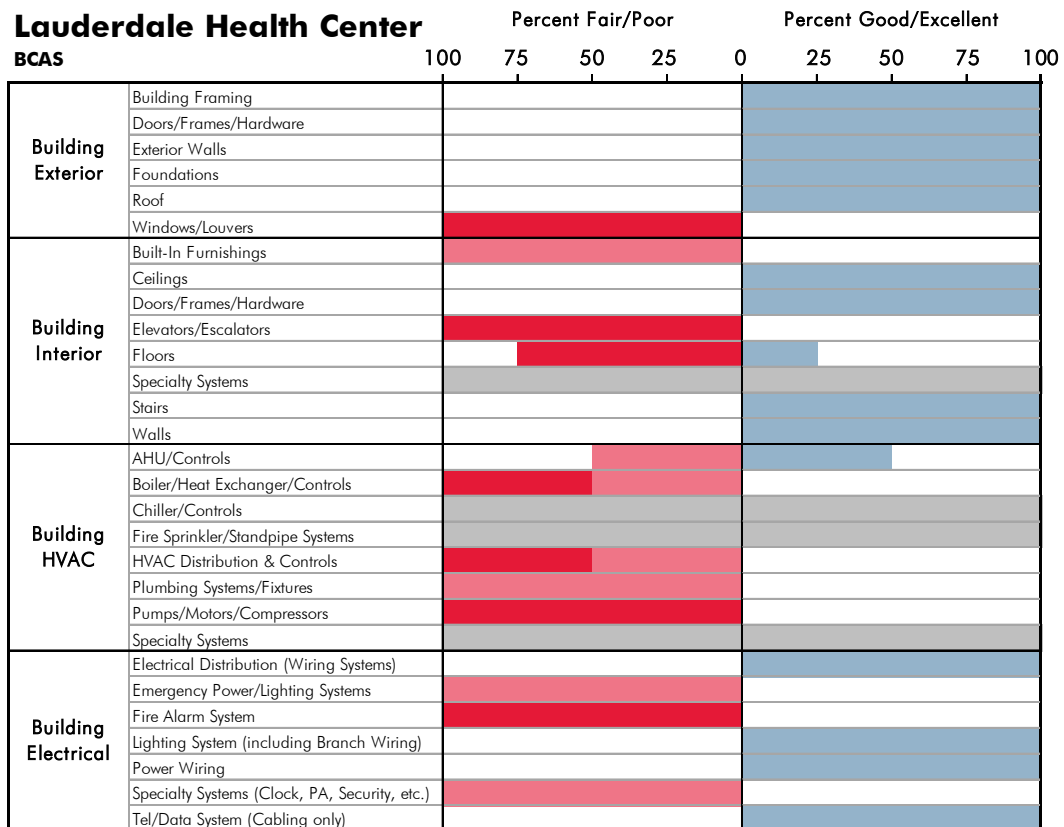
Lauderdale Health Center

Student Health and Counseling Services are located in the Lauderdale Health Center, built in 1966. Located near the center of campus, it can be easily accessed by students living in the North, South, and Central Villages. It houses the medical equipment and supplies necessary for the needs of the students and is staffed by medical personnel. HVAC equipment is old and most of the exhaust fans have failed. Otherwise, the building is in good condition.

- Doors/Frames/Hardware: One of the exterior doors is rusting.
- Windows/Louvers: Single-glazed windows are in fair condition and should be replaced with double-glazed, energy-efficient units.

- Elevators/Escalators: The elevator is in good condition.
- Floors: Floor tile in the first floor corridor is in poor condition. The remaining floors are in good condition.
- Specialty Systems: Some specialty systems, including signage, are in fair condition.
- Stairs: Floor tile at the stairs treads is deteriorating and in poor condition.
- Walls: Vinyl base throughout the building is worn and in fair condition.

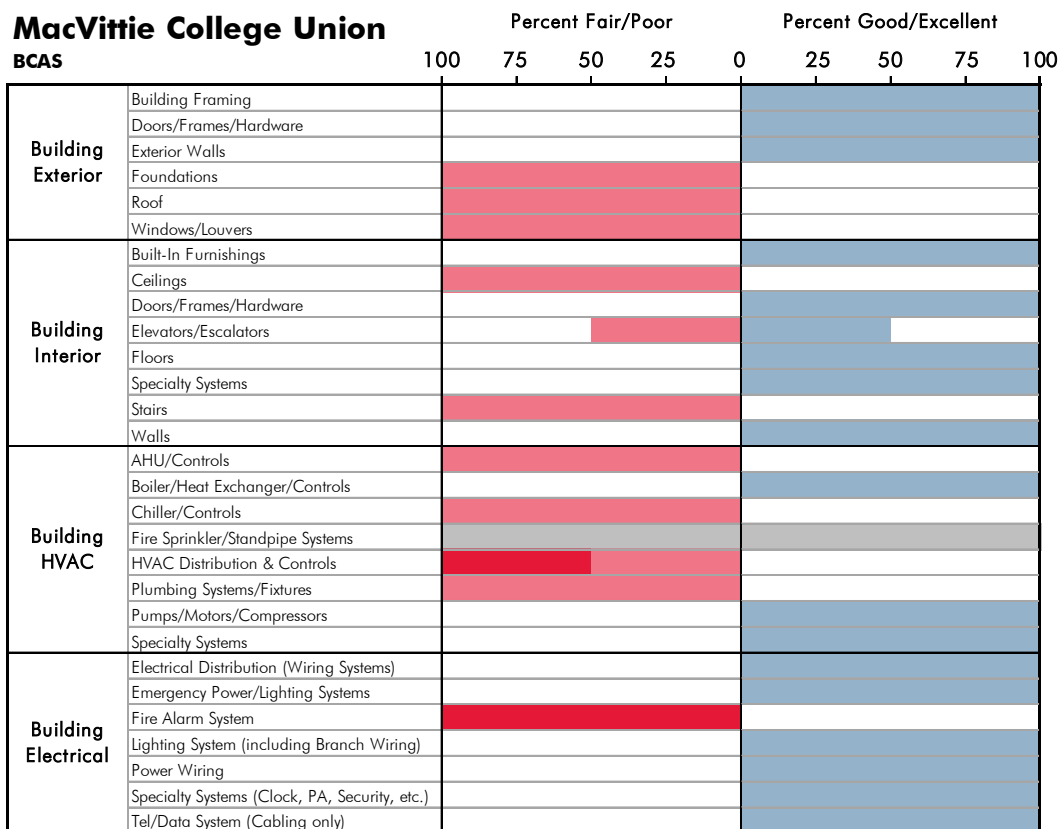
Located in the center of campus, the MacVittie College Union is the hub of recreational and cultural student activities on campus. It includes student organizations, student mailboxes, lounges, meeting rooms, food service, and the Kinetic Gallery, which exhibits student artwork. There is a large community room in the center of the building and a bookstore was recently created on the second floor. Built in 1969, this steel and masonry

building is in fair condition. HVAC equipment that is original to the building is in poor condition. The domestic water tank and steam bundle have failed.

- Doors/Frames/Hardware: Some exterior doors are rusting and in poor condition.
- Exterior Walls: Mortar at the bottom of masonry walls is deteriorating. The metal canopy and exterior ceiling on the west side of the building are in poor condition.
- Windows/Louvers: Many window sills are rusting. Single-glazed windows are not energy-efficient and should be replaced with double-glazed units.

- Built-in Furnishings: Casework in the first floor student activity space and third floor faculty/staff kitchen is in fair condition.
- Ceilings: Some ceilings appear to have been replaced in the last five years and are in good condition. Concealed spline ceilings, however, are in fair condition.
- Floors: Some floor tile is in fair condition based.
- Walls: Gypsum wallboard and wall panels throughout the building are in good to fair condition, with the exception of the newly renovated bookstore.

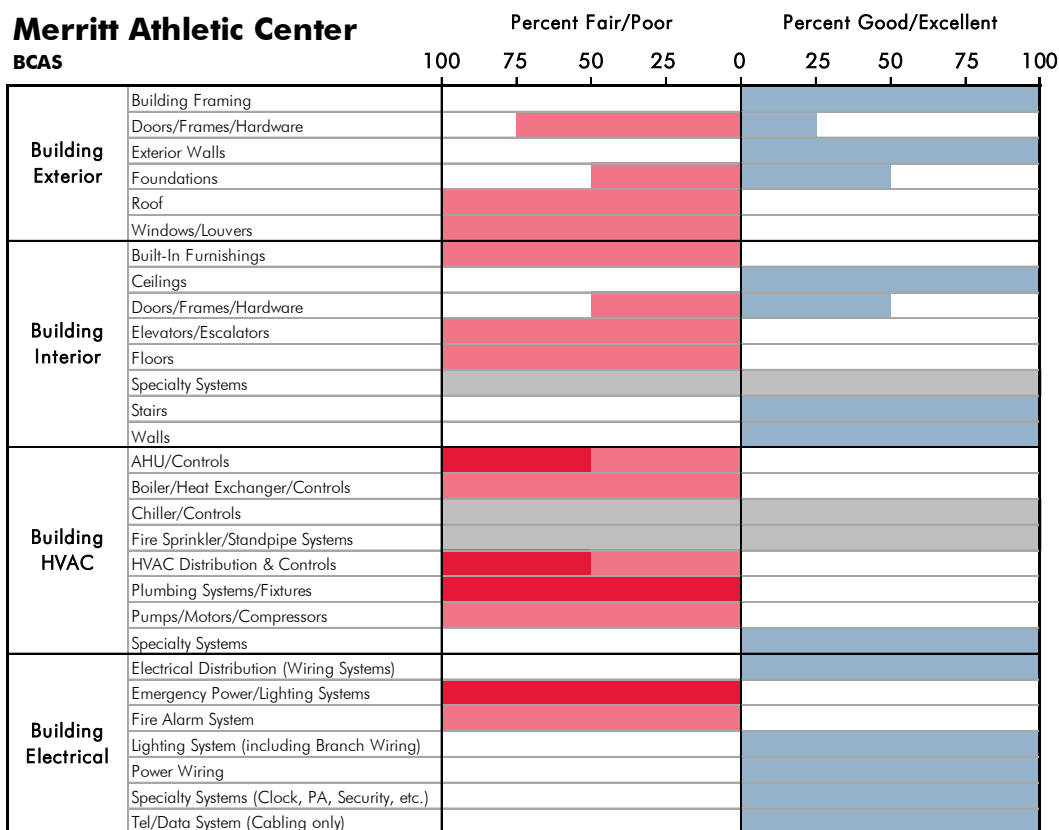
Merritt Athletic Center

of the sidewalk lift, and infrastructure improvements. There are four new air-handling units in the building, but there are also four that are old and in poor condition. Chillers for the Wilson Ice Arena are in good condition. Heating equipment for the pool, however, is in poor condition. The ventilation system needs repairs, but should be replaced in its entirety if large-scale upgrades are done to the rest of the building.

- Framing: Several steel lintels are rusting and in fair condition.
- Doors/Frames/Hardware: Most exterior doors are in good condition.
- Exterior Walls: Masonry walls, mortar, and exterior sealant are deteriorating. Metal fascia panels at the perimeter of the building are beginning to rust.

- Windows/Louvers: Single-glazed windows are in good condition, but not energy-efficient and should be replaced with double-glazed units.

- Floors: Some floors are in good condition.
- Specialty Systems: Some specialty systems, including signage, are in fair condition.

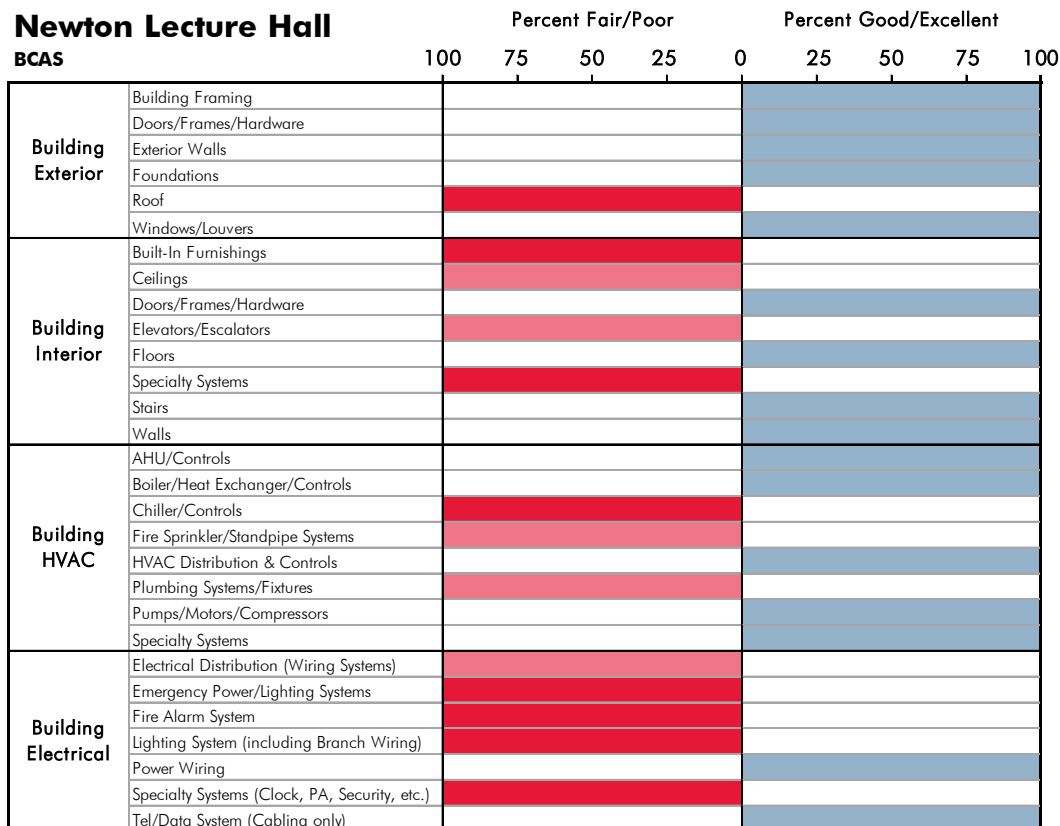
Originally built in 1967 as a stand-alone facility, Newton Lecture Hall was connected to the Integrated Science Center in 2006. It contains five tiered lecture halls and five large classrooms. The first floor contains a graphics lab, faculty offices, and provides access to the lower level of the tiered lecture halls. The chiller and cooling tower are new, but most of the HVAC controls are in poor condition. Infrastructure improvements were completed in 2009 and additional renovations are scheduled for 2013. It is generally in good condition.

- Built-in Furnishings: Seating in the lecture halls is in fair condition.
- Ceilings: Concealing spline ceilings on the first floor are in fair condition. The remaining ceilings are in good condition.
- Doors/Frames/Hardware: Some interior doors are in fair condition.
- Elevators/Escalators: The elevator is in good condition.
- Floors: Floor tile on the first floor is in poor condition. The remaining floors are in good condition.
- Specialty Systems: Some specialty systems, including signage, are in fair condition.

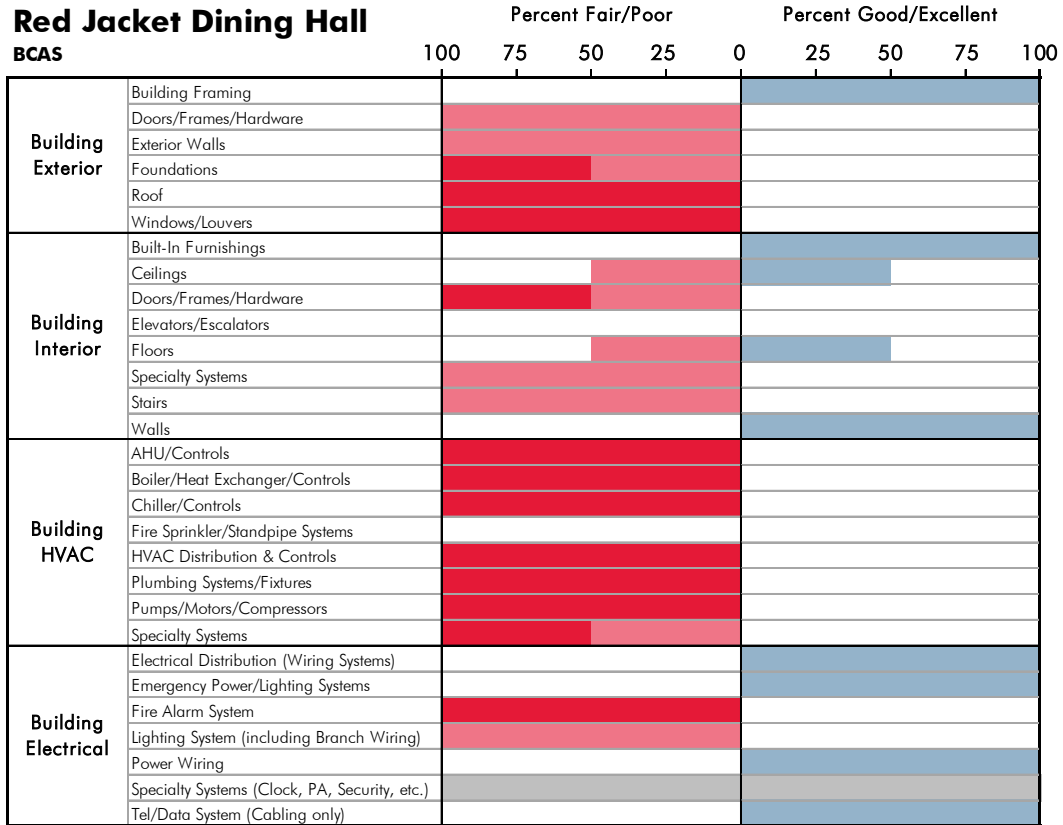
Built in 1967, Red Jacket Dining Hall serves students living in the South Village. It has two large dining areas on the lower level and two assembly areas on the upper level. The kitchen and service area are also located on the lower level. Red Jacket has undergone substantial upgrades since the 2007 BCAS, including new mechanical systems.

- Doors/Frames/Hardware: Exterior doors are in good condition.
- Exterior Walls: Cracks were observed in the masonry veneer on the west side of the building. The age of the cracks is unclear, and they should be monitored.
- Windows/Louvers: Single-glazed windows are not energy-efficient and should be replaced with double-glazed units.

- Ceilings: Acoustic tile ceilings are in good condition.
- Doors/Frames/Hardware: Interior doors are in fair condition, with minor deterioration in some locations.
- Walls: Wood panels in the second floor lobby are starting to deteriorate.

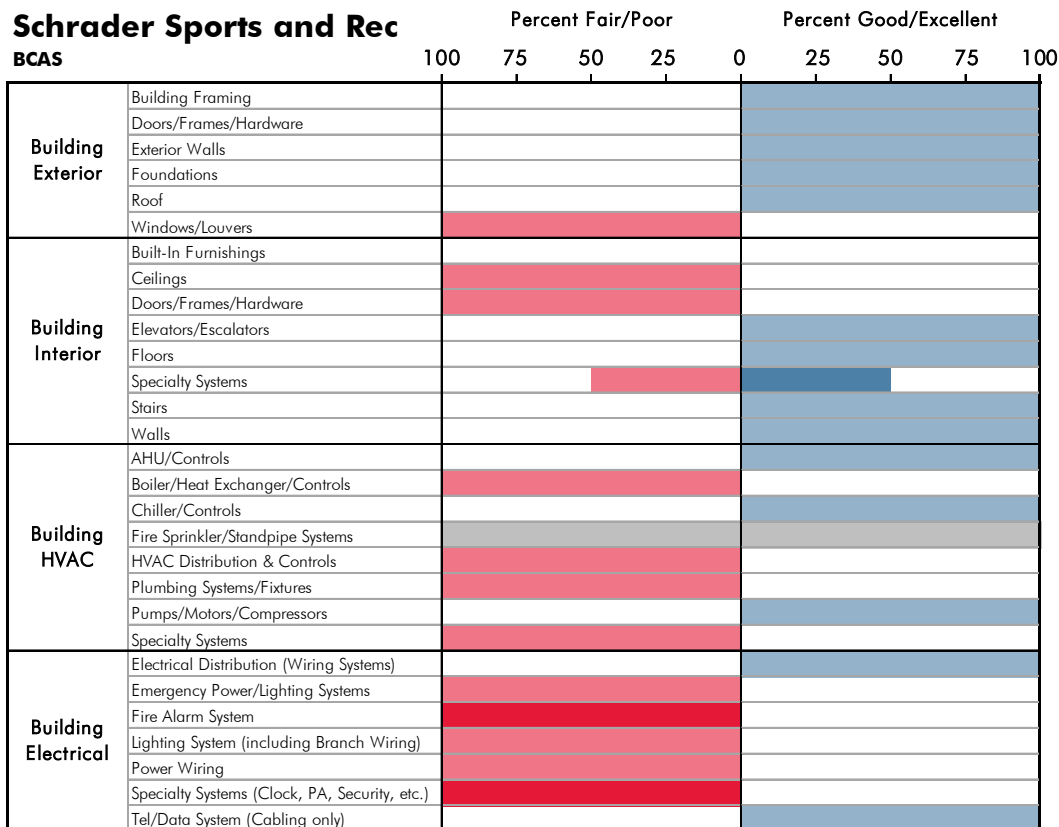
Schrader Sports and Recreation Building

rehabilitated in the last five years. Office space for Residence Living, University Police, and Facilities Planning is also located in the building. HVAC equipment is original to the building and in poor condition. The building is in fair to good condition.

- Exterior Walls: Minor cracks have developed in the masonry veneer on the west side of the pool.
- Foundations: Major cracks in the concrete foundation were found at the southeast corner of the building.
- Windows/Louvers: Single-glazed windows are in fair condition and should be replaced with double-glazed, energy-efficient units.

- Doors/Frames/Hardware: Some doors appear to have been replaced in the last five years and are in good condition.
- Floors: Ceramic floor tile in the Men's Locker Room is in fair condition.
- Specialty Systems: Specialty systems are in good to fair condition.

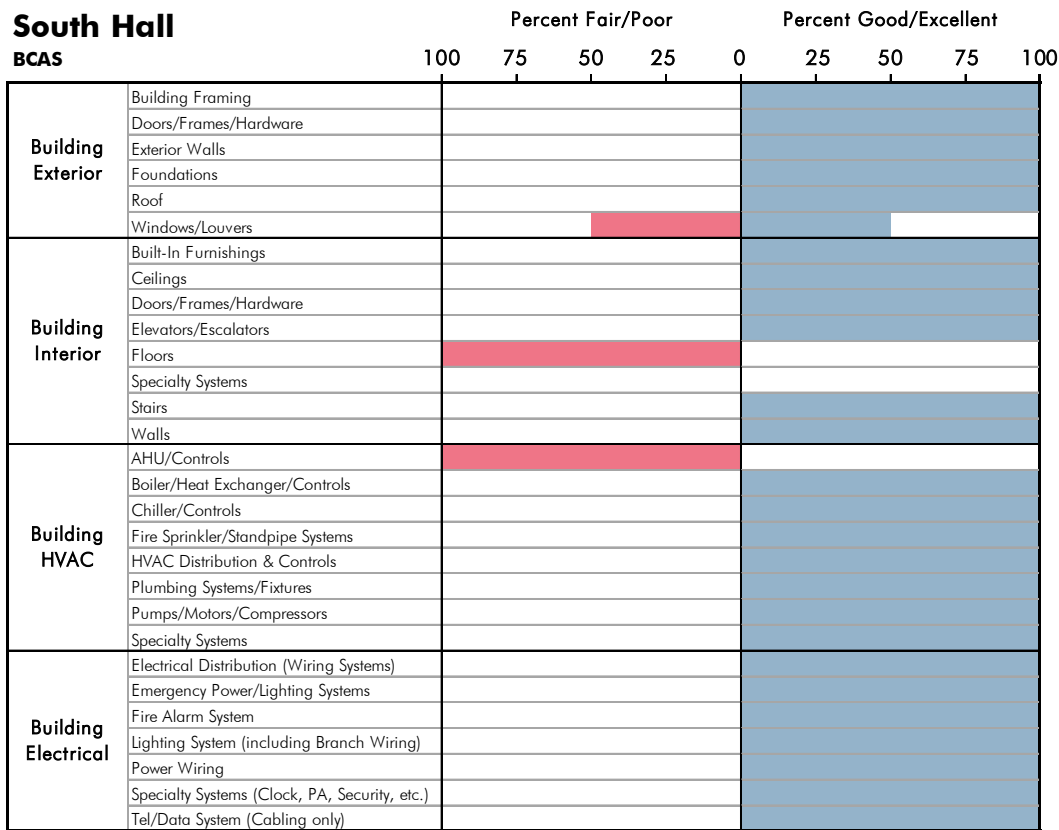
The construction of South Hall in 1995 included the creation of a pedestrian plaza and outdoor classroom behind Welles Hall. It contains space for Business, Computer Science, Education, Mathematics, and the main computing facilities. Classrooms on each floor were developed to meet the programmatic needs of each department. A large lobby adjacent to Park Street provides an informal meeting space for students, faculty, and staff. Several HVAC upgrades have been completed in the last five years. The building is in good condition.

- Exterior Walls: Discoloration of concrete panels above windows on the east side of the building should be addressed by the College.
- Windows/Louvers: Windows and louvers are in good condition.

- Specialty Systems: Specialty systems are in good condition.
- Walls: Wood base throughout the building is in fair condition.

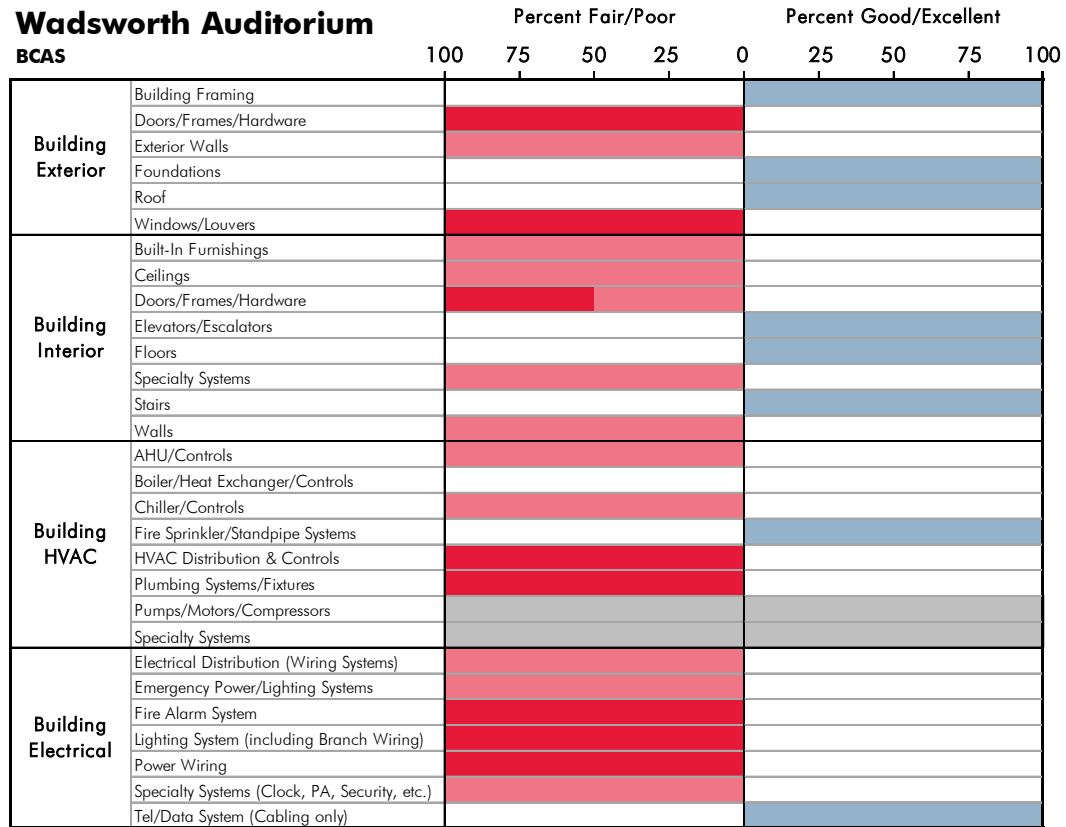
Wadsworth Auditorium was constructed adjacent to Fraser Hall in 1955. It has a tiered classroom on the ground floor and a large auditorium on the main floor. The main entrance faces the College Green and College Circle. HVAC equipment is original to the building and in poor condition.

- Doors/Frames/Hardware: Only a portion of the exterior doors are in poor condition. The remaining doors are in fair condition.
- Exterior Walls: Mortar is deteriorating and in poor condition at several locations around the building.
- Windows/Louvers: Single-glazed windows are in fair condition and should be replaced with double-glazed, energy-efficient units.

- Ceilings: Most ceilings are in good condition.
- Doors/Frames/Hardware: Some interior doors are in good condition.
- Floors: Terrazzo at the main entrance is deteriorating and in fair condition.
- Stairs: Stair treads are worn and in fair condition.
- Walls: Walls are in good condition

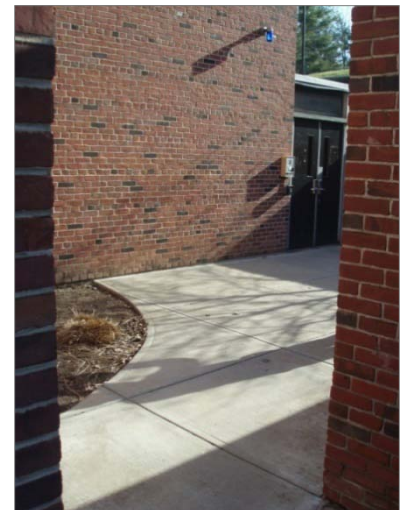
Very few hiding places or secluded areas with limited visibility were observed, with the exception of one small enclosed courtyard at the southeast corner of Steuben Hall, and the art student work area on the north side of Brodie Hall. The area at Steuben Hall is enclosed on four sides with walls that are at least one story high. The entrance into the space is very narrow, and does not allow users to determine if the space is occupied before entering. On the north side of Brodie Fine Arts is a work area for students, with storage of sculpture and other materials that could be dangerous to the general public. The area is unsecured and open to the Academic Quad, although it is screened with evergreens. The college or department may want to consider securing this area.

Enclosed courtyard at Steuben Hall

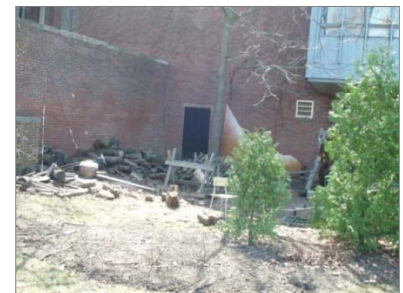
Student work area at Brodie Hall

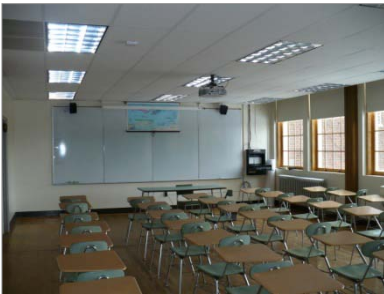
A classroom in Welles

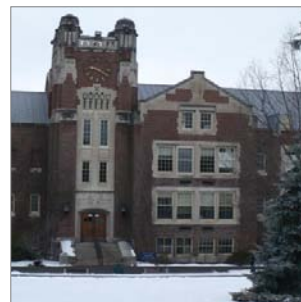
Sturges Hall

Sturges' corridor walls are double thickness except at the ground floor and could not be adjusted without considerable expense. However, there is still a degree of flexibility possible on either side of the corridors should the College decide to address the identified need for more small classrooms by dividing some of the larger ones in Sturges.

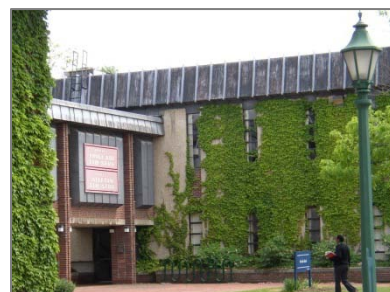
Brodie Fine Arts

Brodie is excellently suited to its function as an art building. It has a variety of studio sizes with good natural light, a theater, faculty offices and gallery space. The central courtyard is appropriate as an outdoor exhibition space and as a whole building gives identity to a department with an extremely wide variety of program needs. While it has good reuse potential from a structural point of view, the existing spaces are so specifically tailored to its current program that it would require a great deal of renovation to convert to another function.

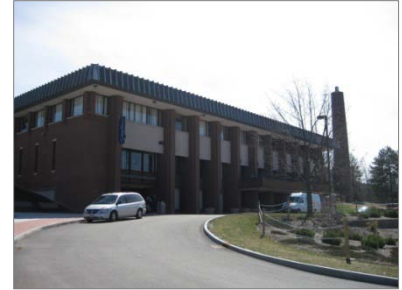
MacVittie from the west

The student Union is appropriately located between the academic, student life, and residential precincts. Designed as a union, it contains a variety of spaces such as a large banquet hall and smaller gathering and eating areas. The main entrance to the north has been well-developed with paving and outdoor tables, and there is a new campus bookstore on the lower level. Despite the fact that it was constructed as a union, MacVittie is not currently suitable for that function. A program study should examine renovation strategies for the building, which has the potential to be well suited as a contemporary student union.

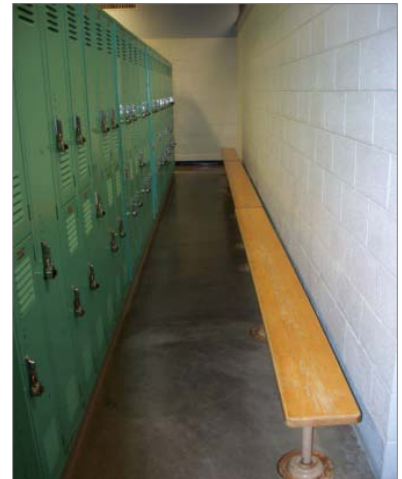
Built in 1973, the Merritt Athletic Center is the largest building on the Geneseo campus. One of the two gymnasiums requires a new floor, and there are security and some vandalism issues within the building. It was noted during field surveys that there were no public toilet rooms on the second floor and there is no direct connection from the locker rooms to the ice rink. However, as with most athletic buildings, its conversion potential is low due to the specialized nature of the spaces, and it is appropriately located on the campus.

Typical lockers in Merritt
